GOVERNOR'S COMMITTEE

COAL MINE DISASTER

BEAR CREEK, MONTANA

The undersigned, comprising the Committee appointed by you to investigate the mine disaster at the Smith Mine of the Montana Coal & Iron Company, at Washoe, in Carbon County, Montana, respectfully submit the following report:

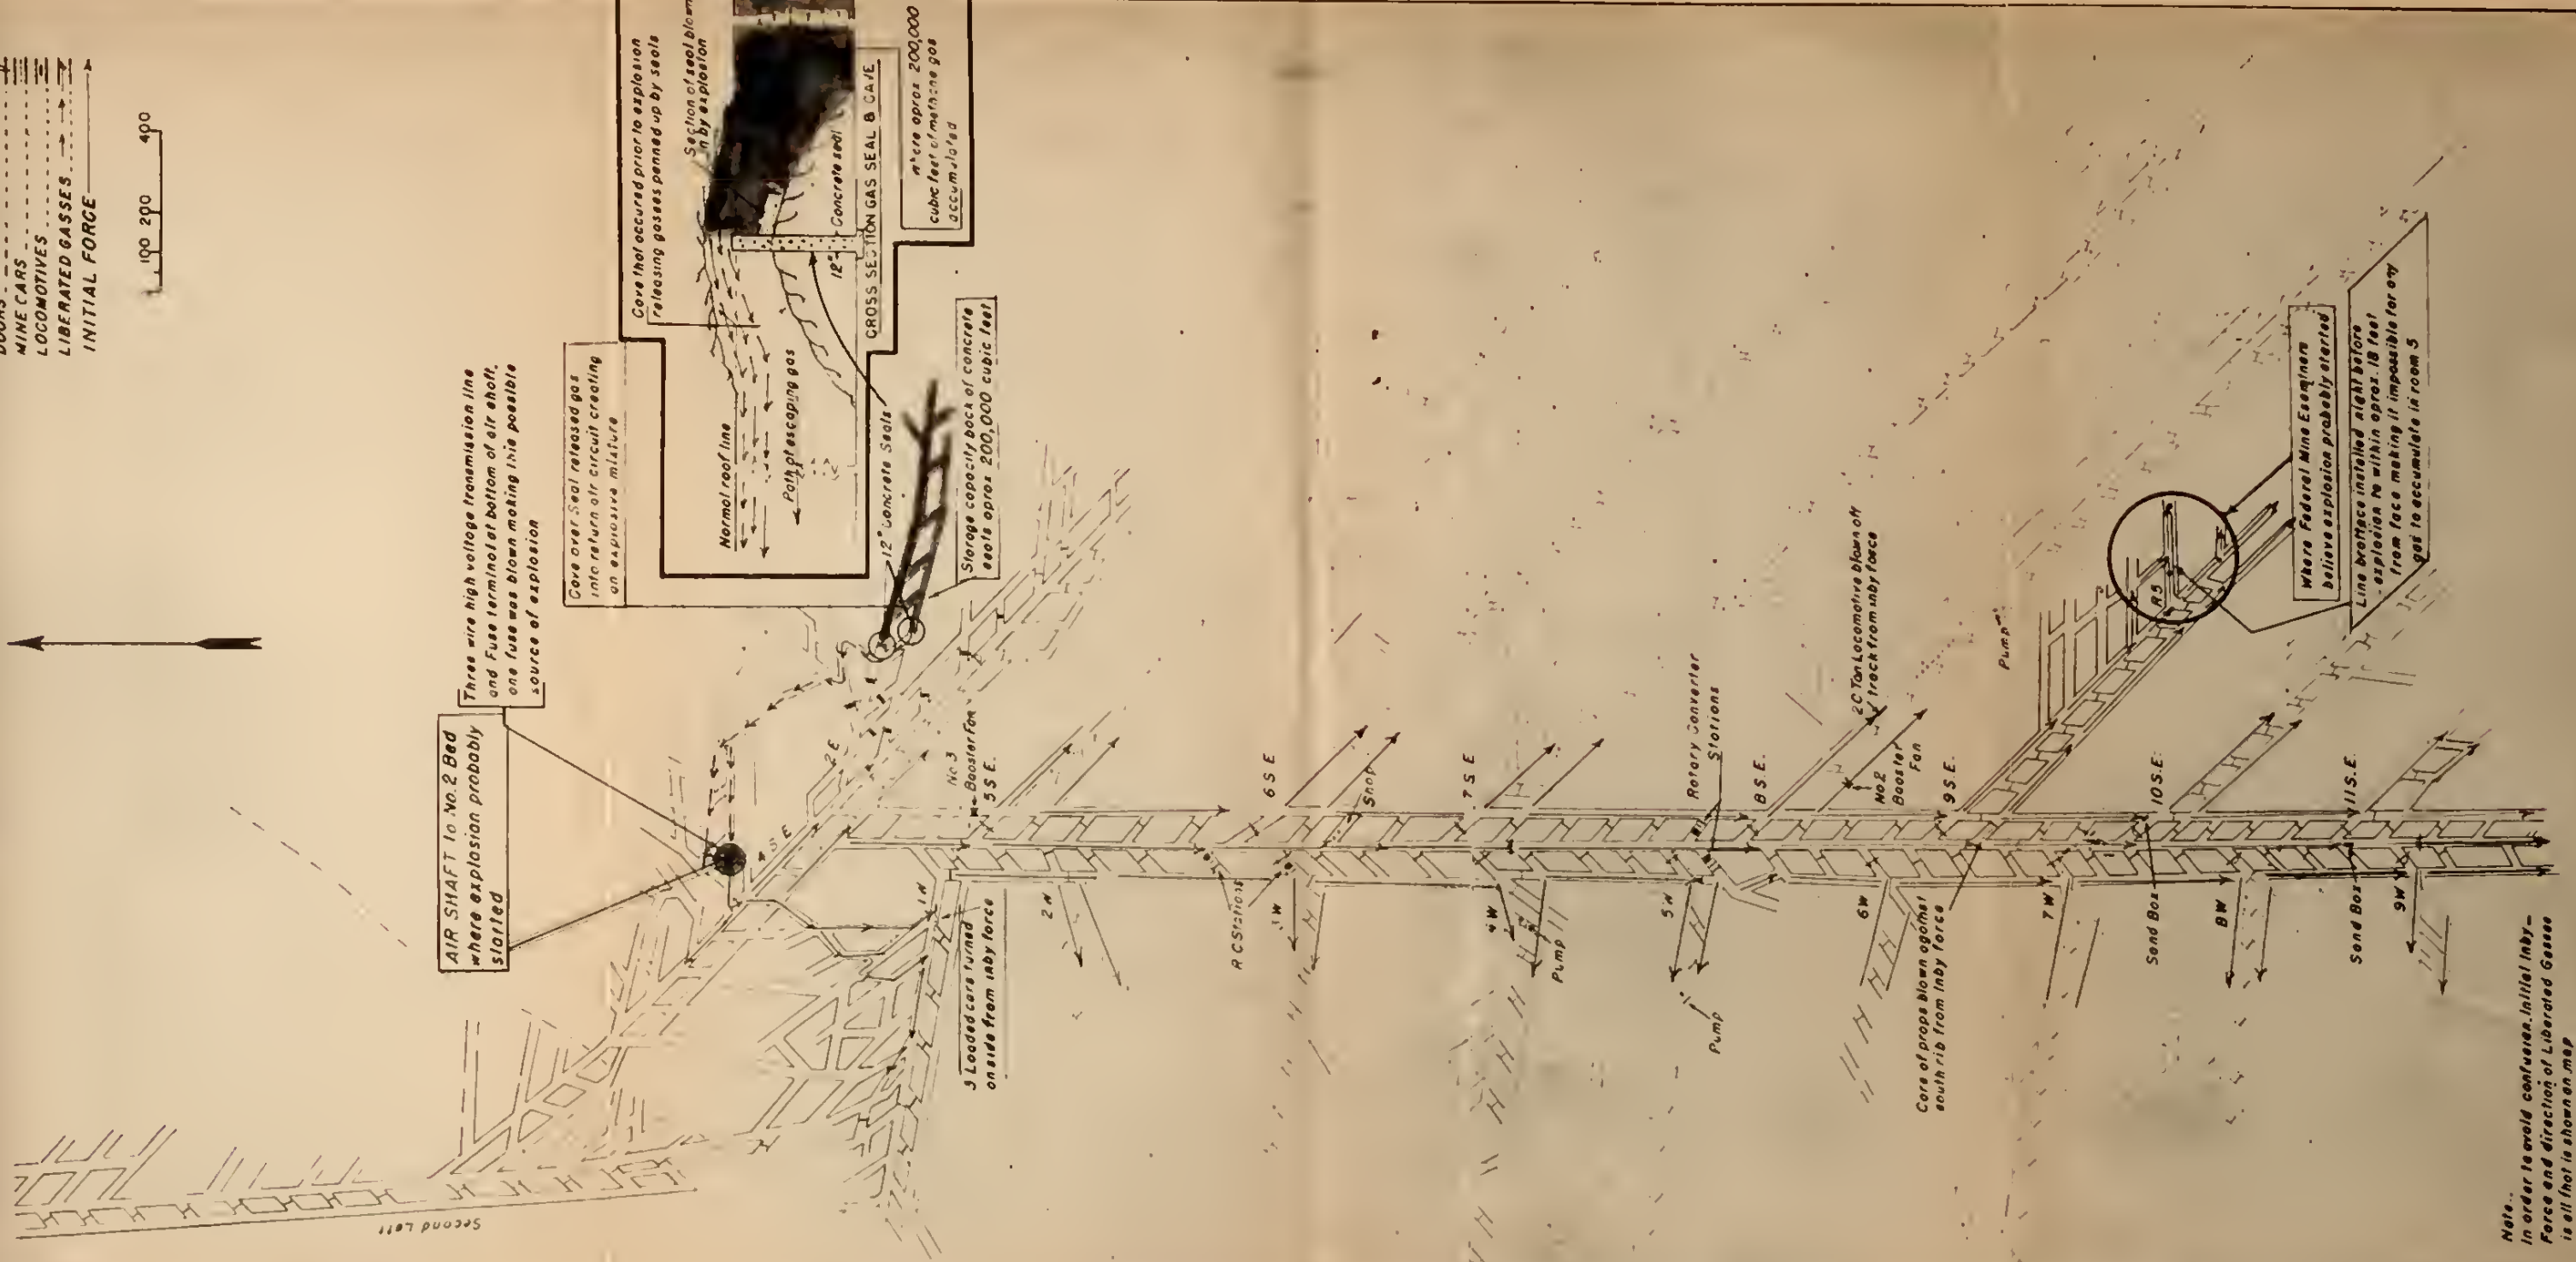
DOUBLE BOARD STOPPINGS
DOORS
MINE CARS
LOCOMOTIVES
LIBERATED GASES
INITIAL FORCE

Note:
In order to avoid confusion, initial inby force and direction of liberated gases is all that is shown on map.

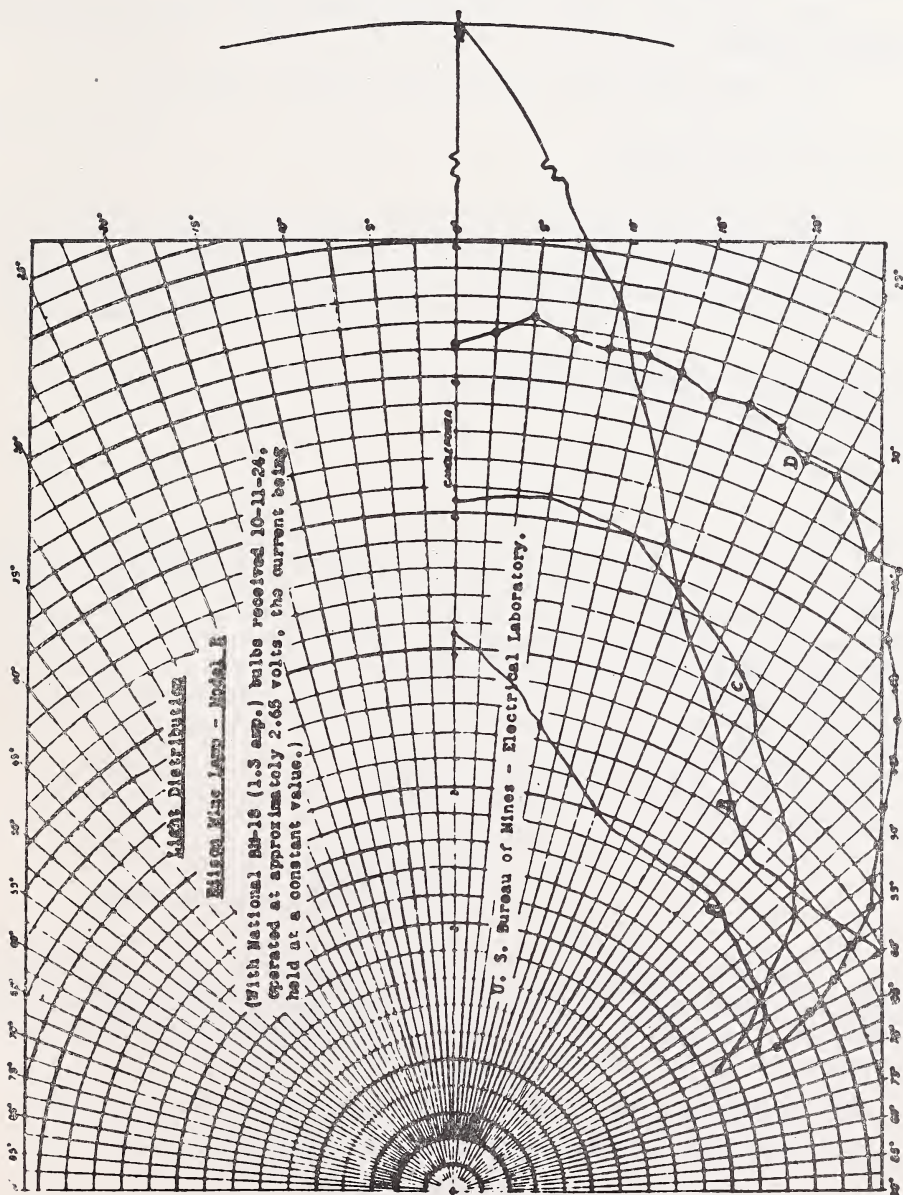
The tests made with the open flame carbide lamps using an average of $1\frac{1}{2}$ inch flame with tarnished reflectors gave a maximum of four and one-tenth (4.1) candlepower. However, the reflectors used were in about the same condition that a new lamp would be after being used a short time, with the exception that the reflectors were clean, whereas in use the reflectors would quickly become dirty as well as tarnished, and the above candlepower value further reduced.

Tests made with Edison electric safety cap lamp with new approved bulb gave six and two-tenths (6.2) candlepower at center of light distribution, over

A—Carbide lamp with tar-
nished reflector and
flame $1\frac{1}{8}$ " long.

B—Carbide lamp with po-
lished reflector and
flame $1\frac{1}{8}$ " long.
